Onagawa Seismically-Induced HEAF Fire Event

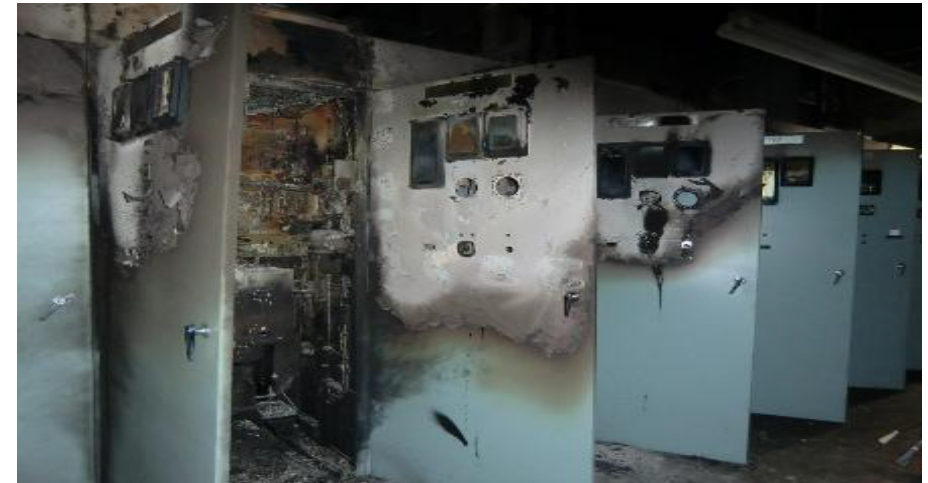
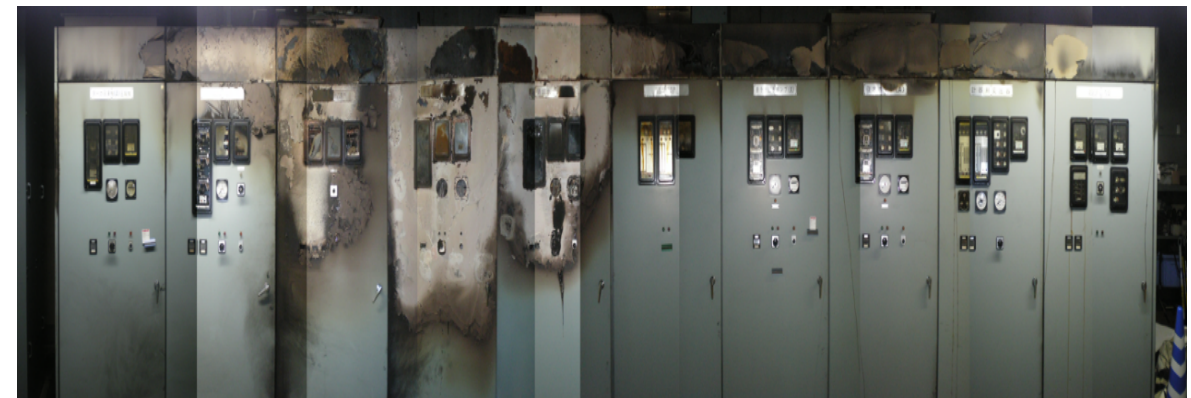
- ❑ Fire sequence and consequences
 - ❑ Fire detected by optical detector, although onsite fire brigade could first not identify fire location due to heavy smoke
 - ❑ Actuation of fixed CO₂ extinguishing system for some rooms after turbine building evacuation
 - ❑ External public fire brigade called could not support onsite resources because of blocked access ways
 - ❑ Fire duration of nearly 8 h, one safety train lost
 - ❑ All 10 cubicles completely damaged by fire, left 3rd one mostly damaged because high energy gas in the section where the fire started could propagate to other sections
